**DOT/FAA/AR-95/90**

# **Spin Synchronous X-Ray Sinography (SXS) for Nondestructive Imaging of Turbine Engines Under Load**

March 1996

Final Report

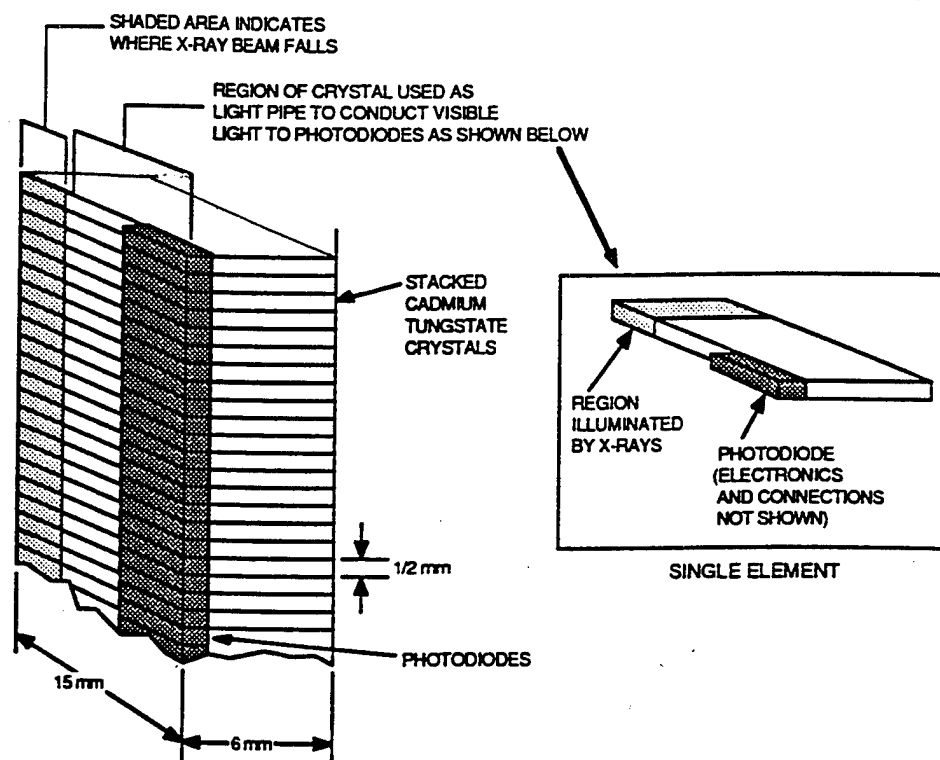
The output beam on the detector side of the engine presents a one-dimensional shadowgraph image of the engine at the time of the X-ray pulse. The detector is composed of a strip of contiguous detection elements, each detector being approximately 0.5 mm wide, 15 mm long, and 6 mm thick, as shown in figure 1-4. This arrangement gives good X-ray stopping power, reasonable light collection efficiency, and good spatial resolution of the interior of the test specimen. The array length in our demonstration system is approximately 8 in. and is composed of 512 elements. (A production system has 1000 to 2000 elements.) The configuration shown in figure 1-1 positions the 1000 element production system array symmetrically about the engine axis - there is just as much array above as below the motor centerline. This yields coverage of 250 mm (10 in.) in radius. The detector array can also be positioned on one side of the centerline, a configuration yielding about 500 mm (20 in.) coverage in radius.

FIGURE 1-4. DETECTOR STRIP

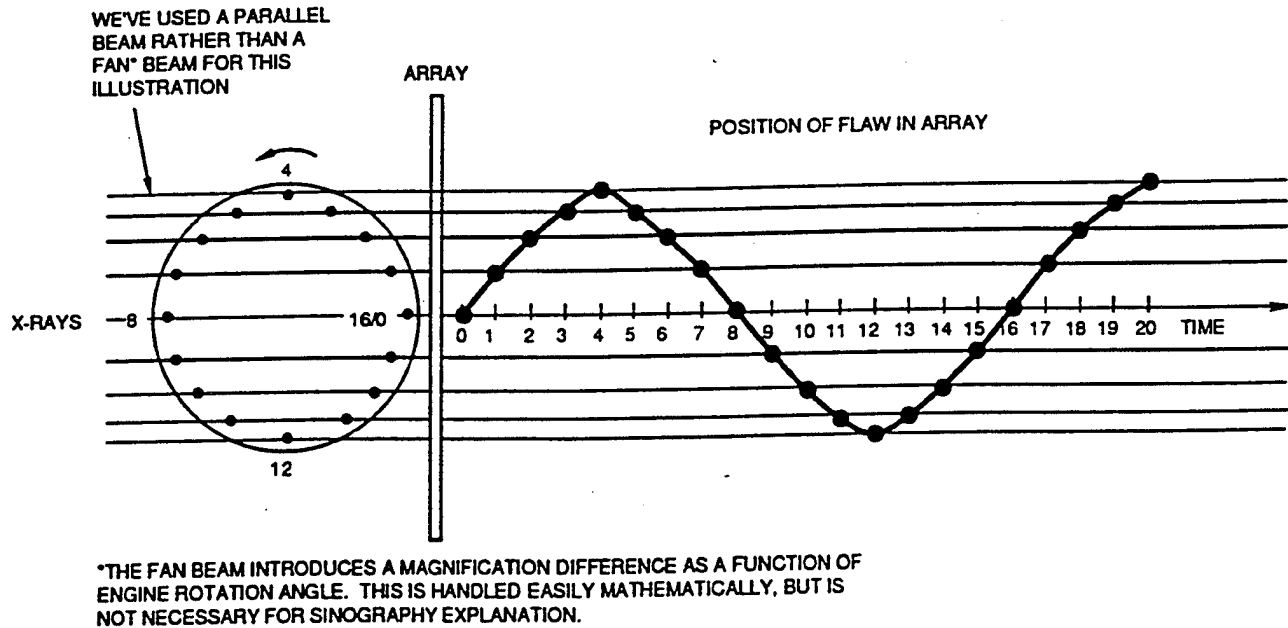
Given this configuration, it must be asked what the appearance of a suspect (flawed) region will be in a single one-dimensional image of the plane: for this discussion it will be assumed a single point flaw, as shown in figure 1-5. As the engine is rotated, the X-ray shadow of the point flaw on the array is as shown in figure 1-5. If the outputs of the array are plotted in time, the flaw traces out the pattern of a sine curve. The amplitude shows how far out in radius the feature is located, and a correlation with rotational position locates the feature in angle on the

FIGURE 1-5. APPEARANCE OF POINT FLAW IN DETECTOR AS ENGINE ROTATES

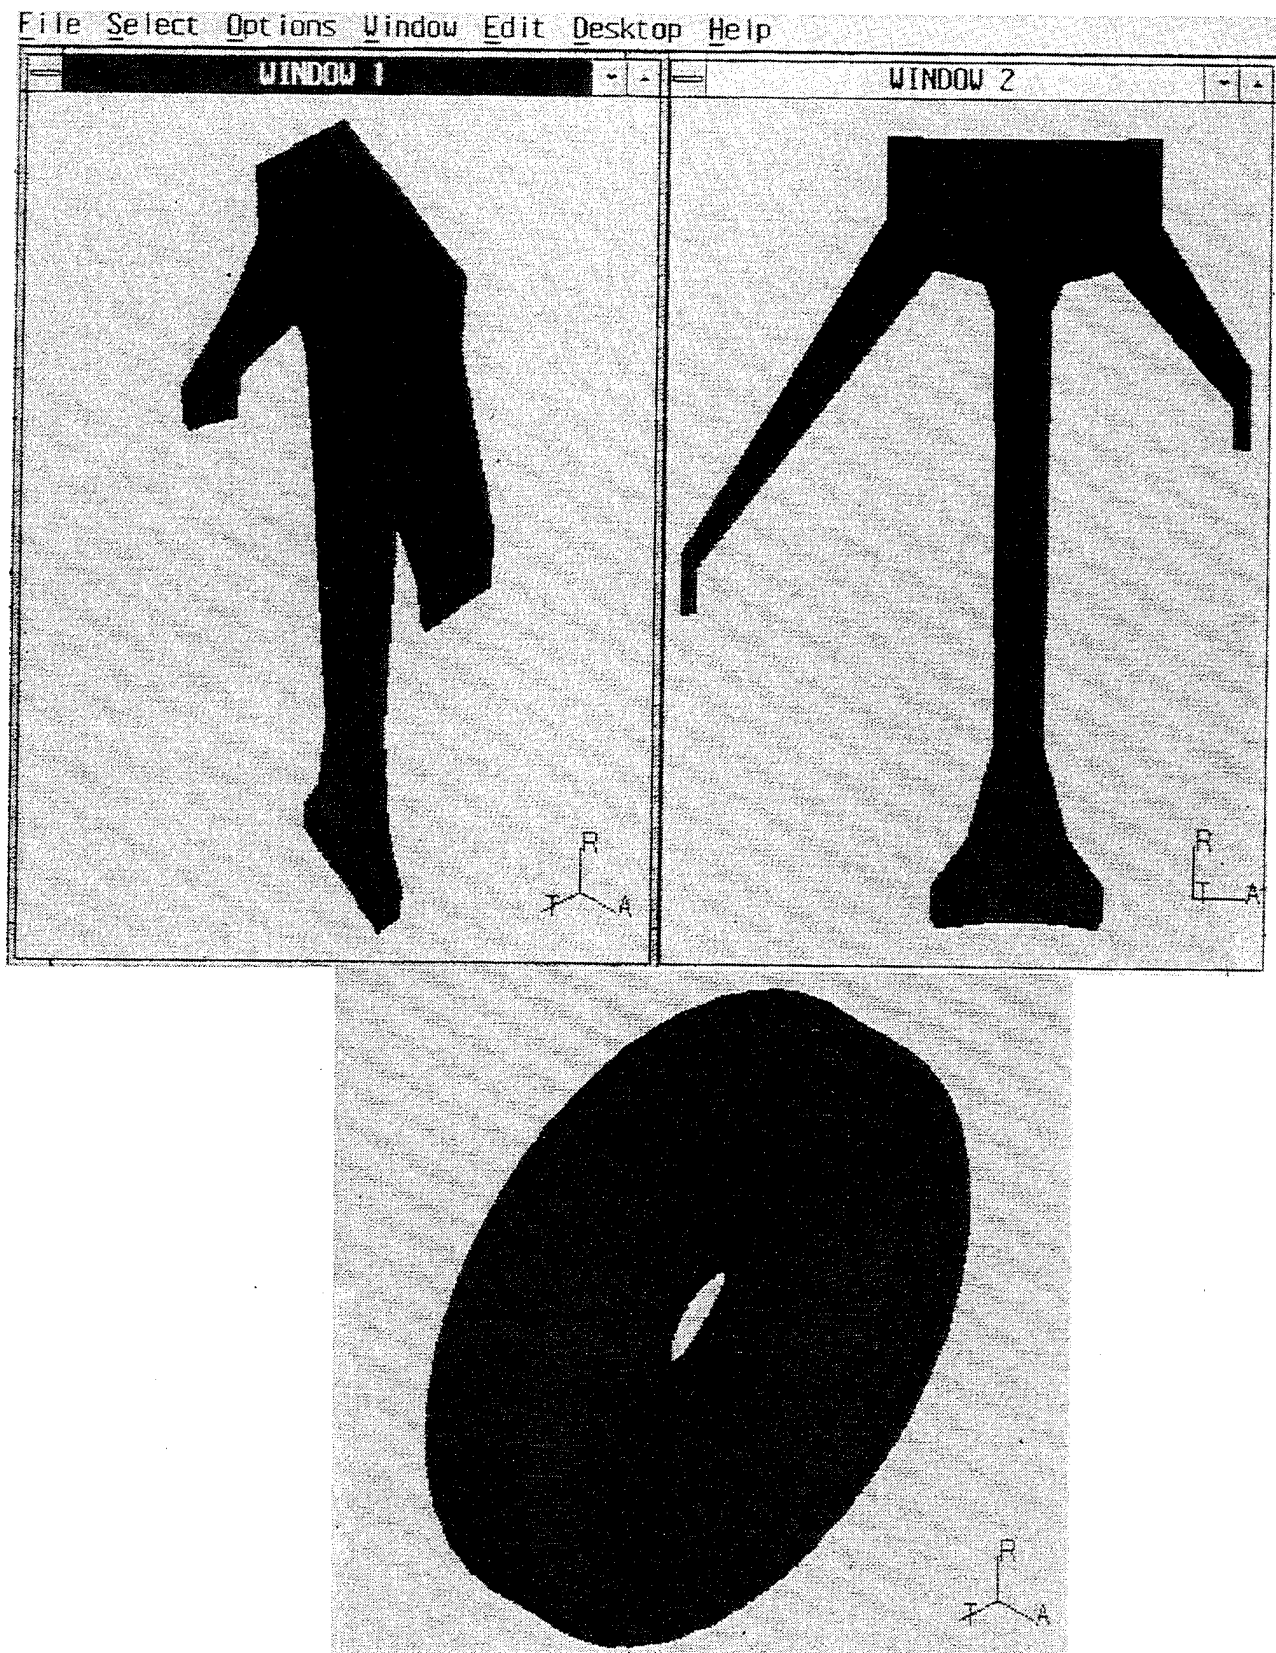
FIGURE 2-1. FINITE ELEMENT MODELS OF ROOT-DISK STRUCTURES

Rotational forces and heat are the two most obvious factors in changing the size of cracks in disks under operating conditions. In our expert opinion and confirmed by STI, the increases in crack size due to heat are negligible compared to those due to spinning forces. The overall disk model is shown in figure 2-1. The crack positions within the disk are shown in figure 2-2 and figure 2-3.

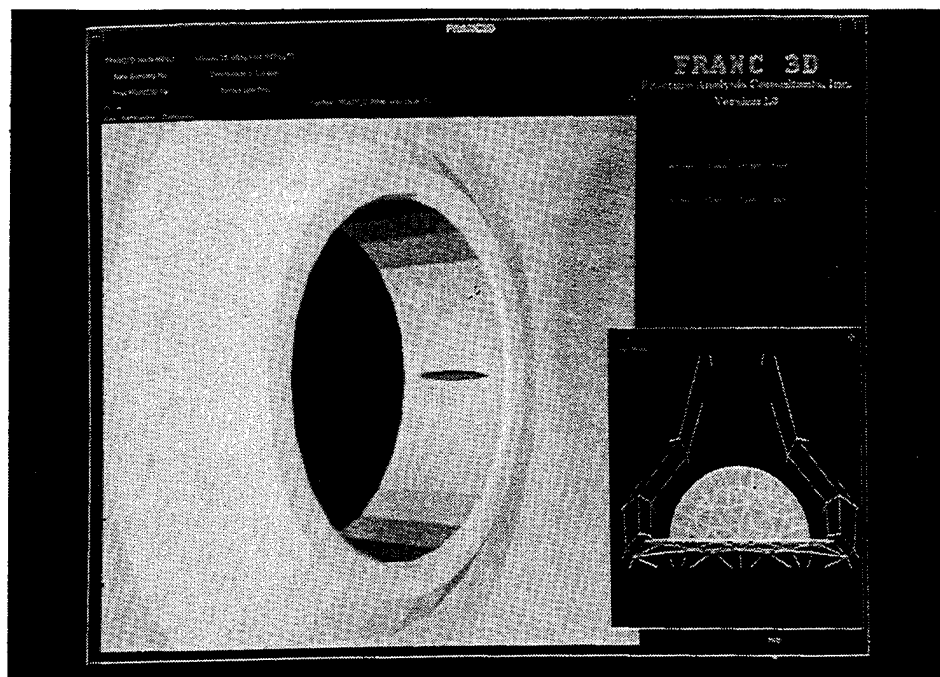
FIGURE 2-2. DETAILS OF A DEFORMED SURFACE CRACK

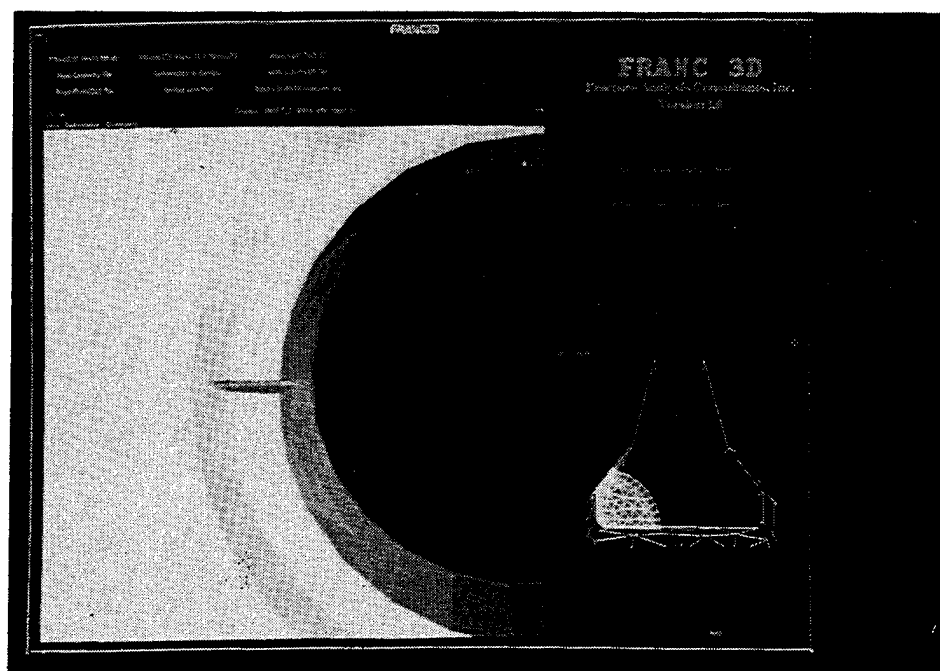
FIGURE 2-3. DEFORMATION OF A CORNER CRACK (SOLID PLOT)

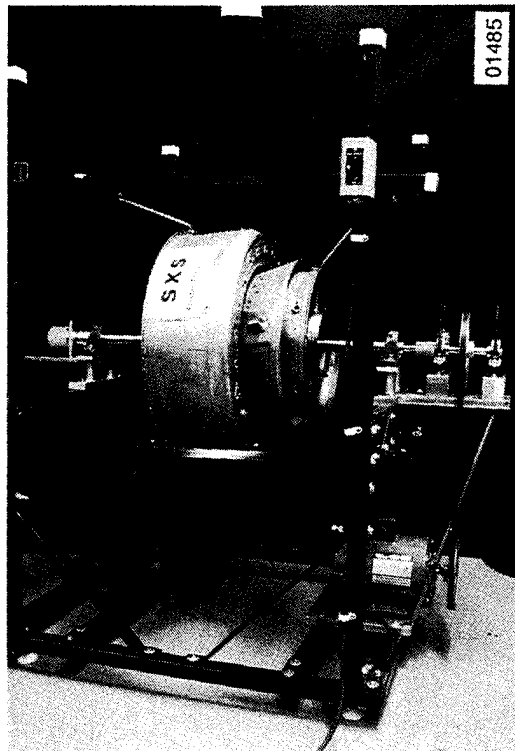
A demonstration was conducted on the turbine section of an actual Lycoming turboshaft engine, a T53-L-II provided by the FAA. The turbine section was spun externally by an electric motor for this test in a confined X-ray bay. The T53 turbine section is shown in figure 3-1. In addition, a supplementary disk, with built-in defects as shown in figure 3-2 was manufactured and mounted on the turbine disk. The defects consisted of a series of radial cracks, approximately 1/8 in. in length and of widths ranging from 0.0005 to 0.01 in., located in two annular bands and having approximate diameters of 3 and 7 in. This experiment focused on the 3-in.-diameter band of radial cracks.

FIGURE 3-1. TURBINE SECTION OF T53 TURBOJET ENGINE SHOWN ON STAND WITH ITS ELECTRICAL DRIVE SYSTEM ON RIGHT AND SHAFT POSITION ENCODER ON LEFT

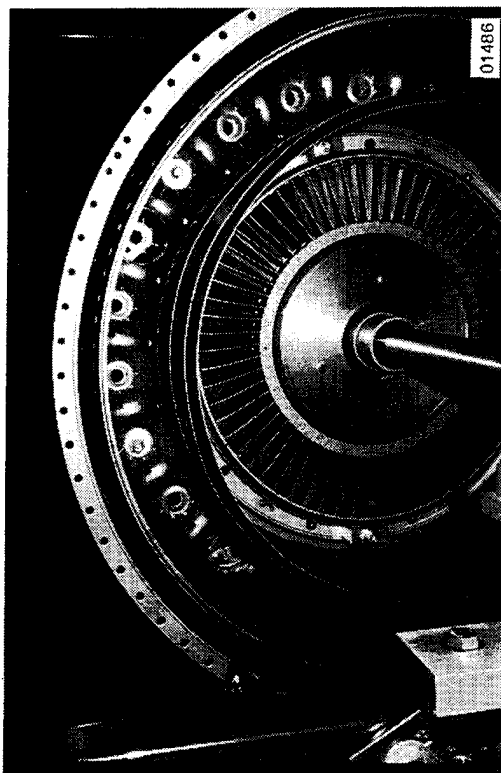
FIGURE 3-2. SUPPLEMENTARY DISK WITH CALIBRATED RACKS AS MOUNTED ON T53 SECOND STAGE TURBINE DISK

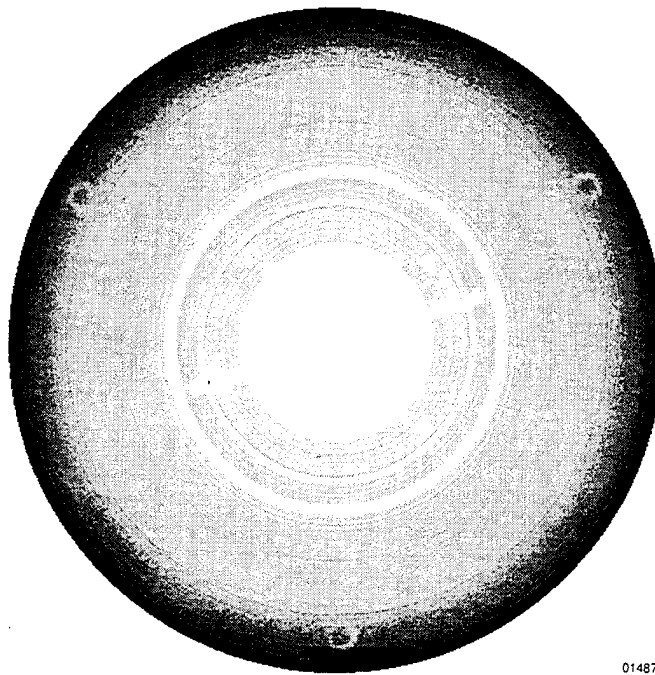
The reconstructed annulus of figure 3-3 extends through radii from 0.75 to 2.5 in. Imaged in this annulus are the tapering outer radius of the turbine axle (1.15 in.) and the inner radius of the phantom disk (1.31 in.). Within the turbine axle are shown two diametrically located slanting oil ports (the 0.012 in. dimension is in the tangential direction on figure 3-4). The radial extent is much larger. Near the outermost radius of the reconstructed annulus, spaced 120 degrees apart, are imaged the three bolts which were used to secure the phantom disc to the turbine. In fact, it is the space between each bolt and its hole that is imaged here. This gap, nominally 0.010 in., produced a 20 percent modulation with a full width half maximum (FWHM) of about 0.04 in., corresponding roughly to a image-derived gap width of 0.008 in. In other words, the equivalent

FIGURE 3-3. THIS RECONSTRUCTION OF THE PHANTOM DISK CLEARLY SHOWS THE OIL PORTS IN THE TURBINE AXLE, THE GAP BETWEEN THE AXLE AND THE PHANTOM DISK, AND THE 0.008-INCH GAP BETWEEN THE PHANTOM'S THREE MOUNTING BOLTS AND THEIR RESPECTIVE HOLES. OTHER CONCENTRIC CIRCULAR FEATURES, AS WELL AS THE GRADUAL RADIAL GRADIENT, CAN BE REMOVED AS SHOWN IN FIGURE 3-4.

width\* of the missing materials as measured in a density profile across the screw and hole corresponds to an average gap of 0.008 in. The actual clearance between the screw whole and the bolt is smaller than 0.008 in. The average gap in terms of X-ray throughput is the sum of the bolt to hole clearance plus the missing material between the major and minor diameter of the threads. CT and CT-derivative techniques are often used to make such quantitative estimates of gaps, clearances, and the like.

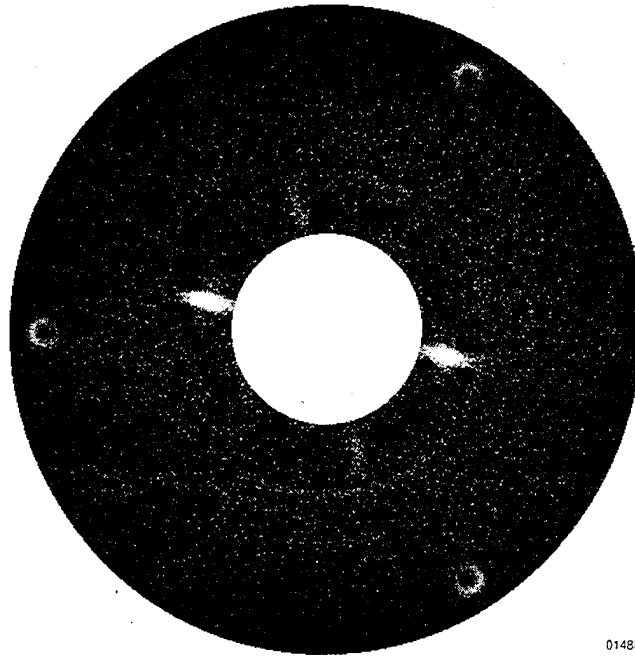
FIGURE 3-4. SELECTIVE FILTERING OF CIRCULAR FEATURES ENABLES OTHER FEATURES TO BE MORE EASILY OBSERVED. TO SEE WHY THE PHANTOM GAPS ARE NOT DETECTABLE IN THIS PROCESSED RECONSTRUCTION, IMAGINE TRANSPLANTING A 60-DEGREE PORTION OF THE NOMINAL BOLT RING SIGNAL INTO THE HIGHER AMBIENT NOISE REGION JUST BEYOND THE OIL-PORT RADIUS.

Among the phantom's radial gaps, the largest is located at about 225 degrees (four o'clock) just outside the inner radius of the phantom. This gap, though similar in width to the bolt gap just discussed, is much shorter (0.13 versus 0.67 in.). To be reliably detectable, such a feature must produce a modulation about three times the image noise level. The noise level (standard deviation) in this reconstruction is about five percent (increasing to 6 percent at the gap radius).

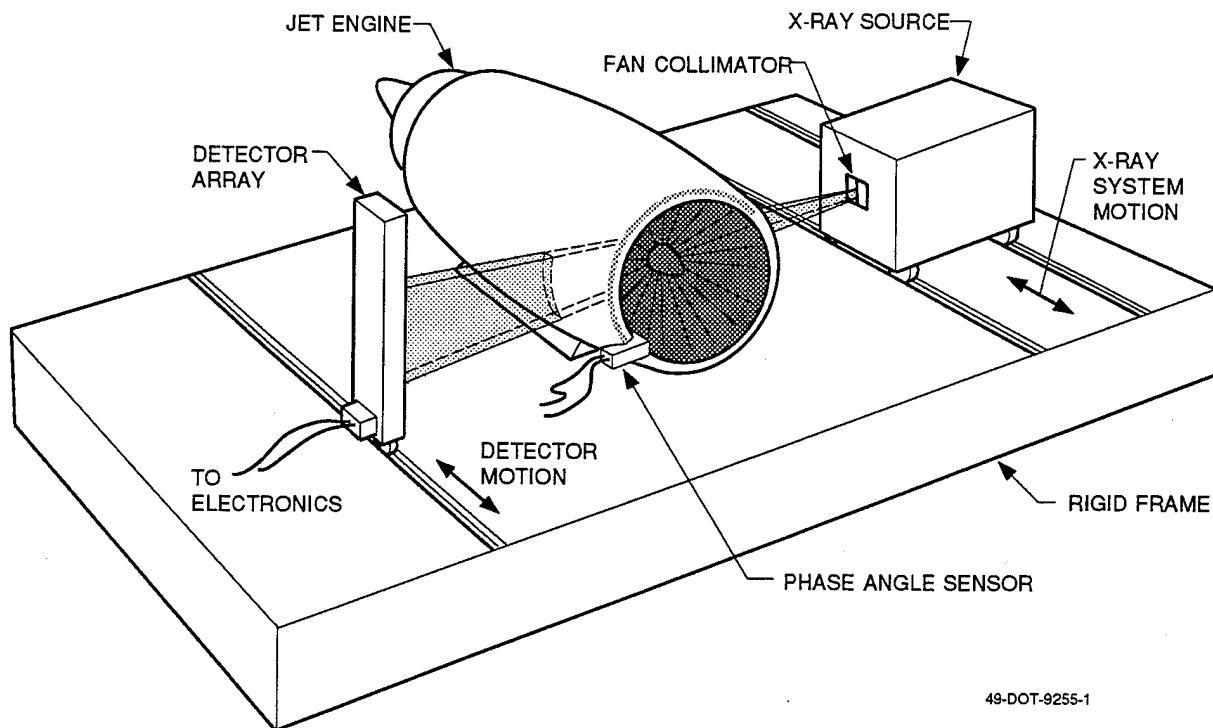
FIGURE 5-1. SXS TEST CELL CONFIGURATION

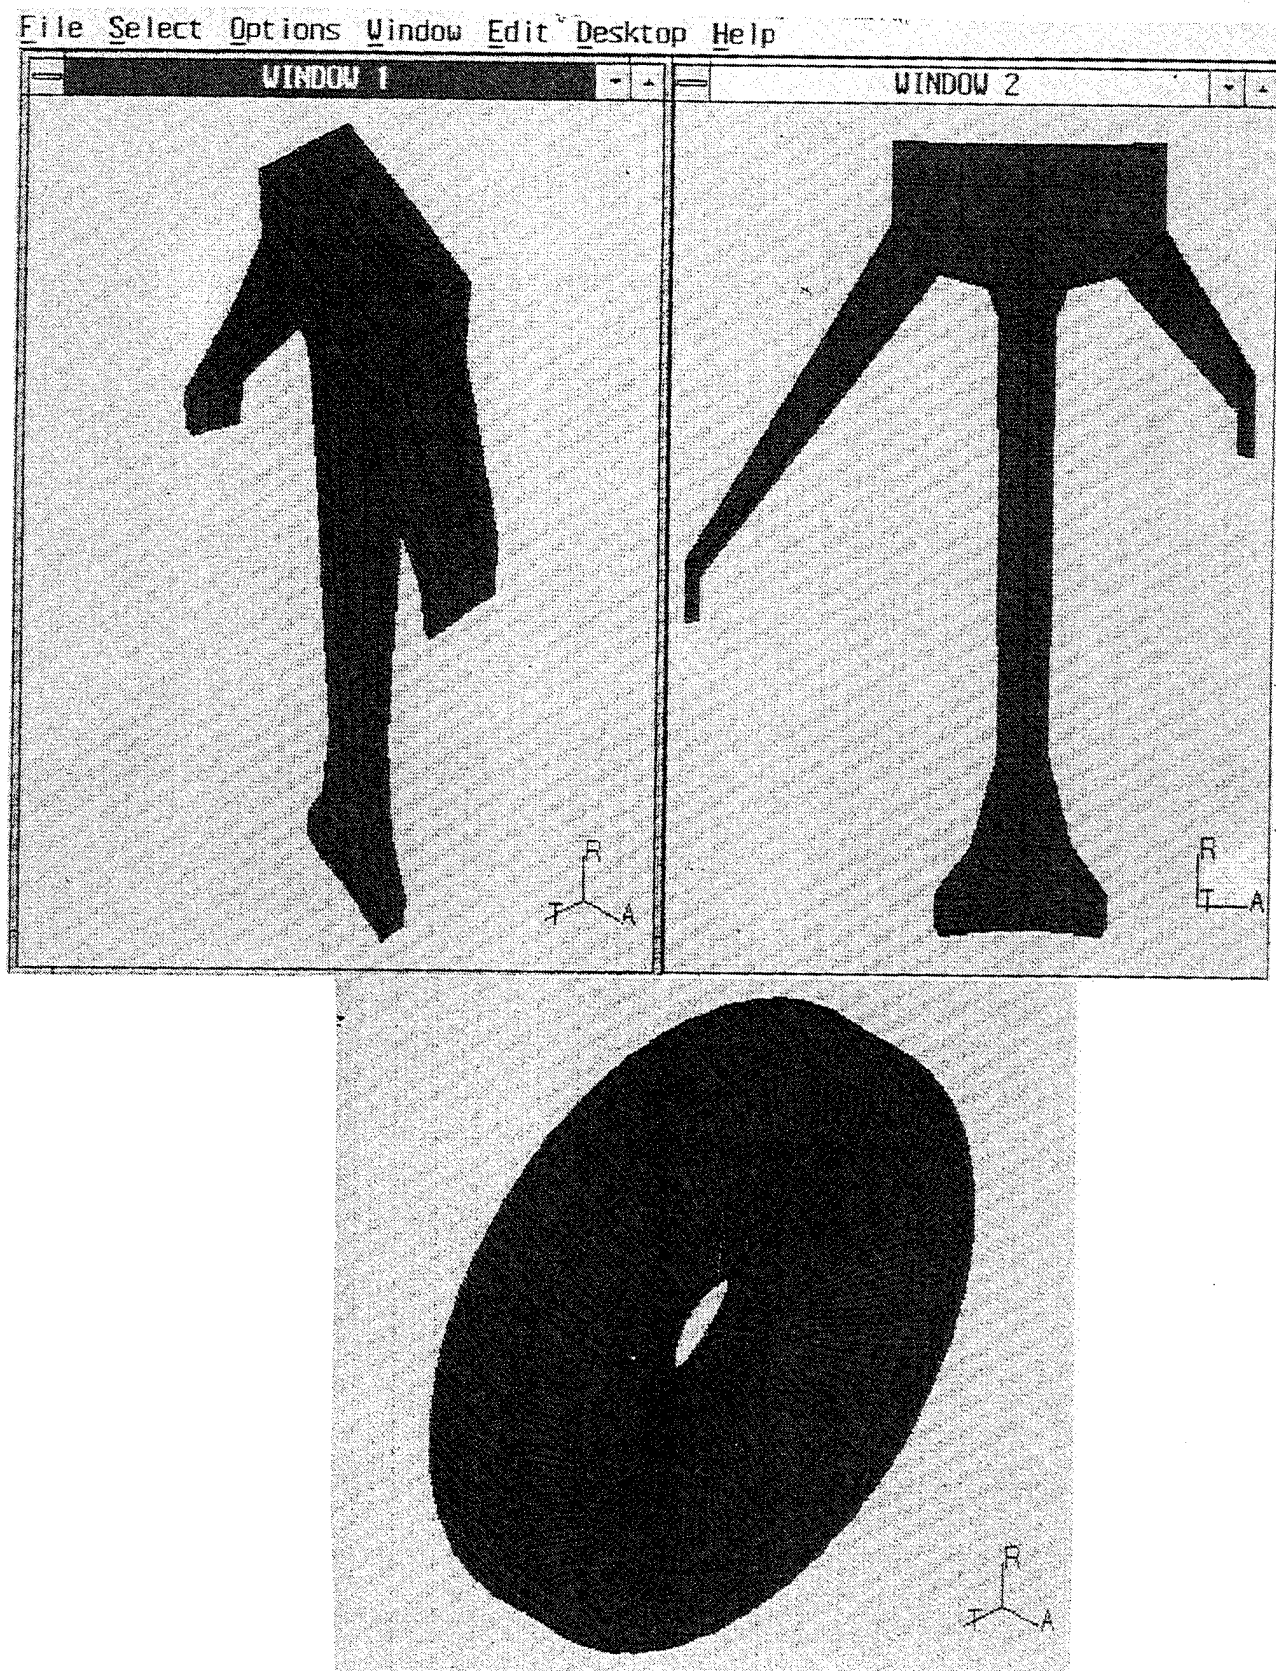
FIGURE 1.1 FINITE ELEMENT MODELS OF ROOT-DISK STRUCTURES

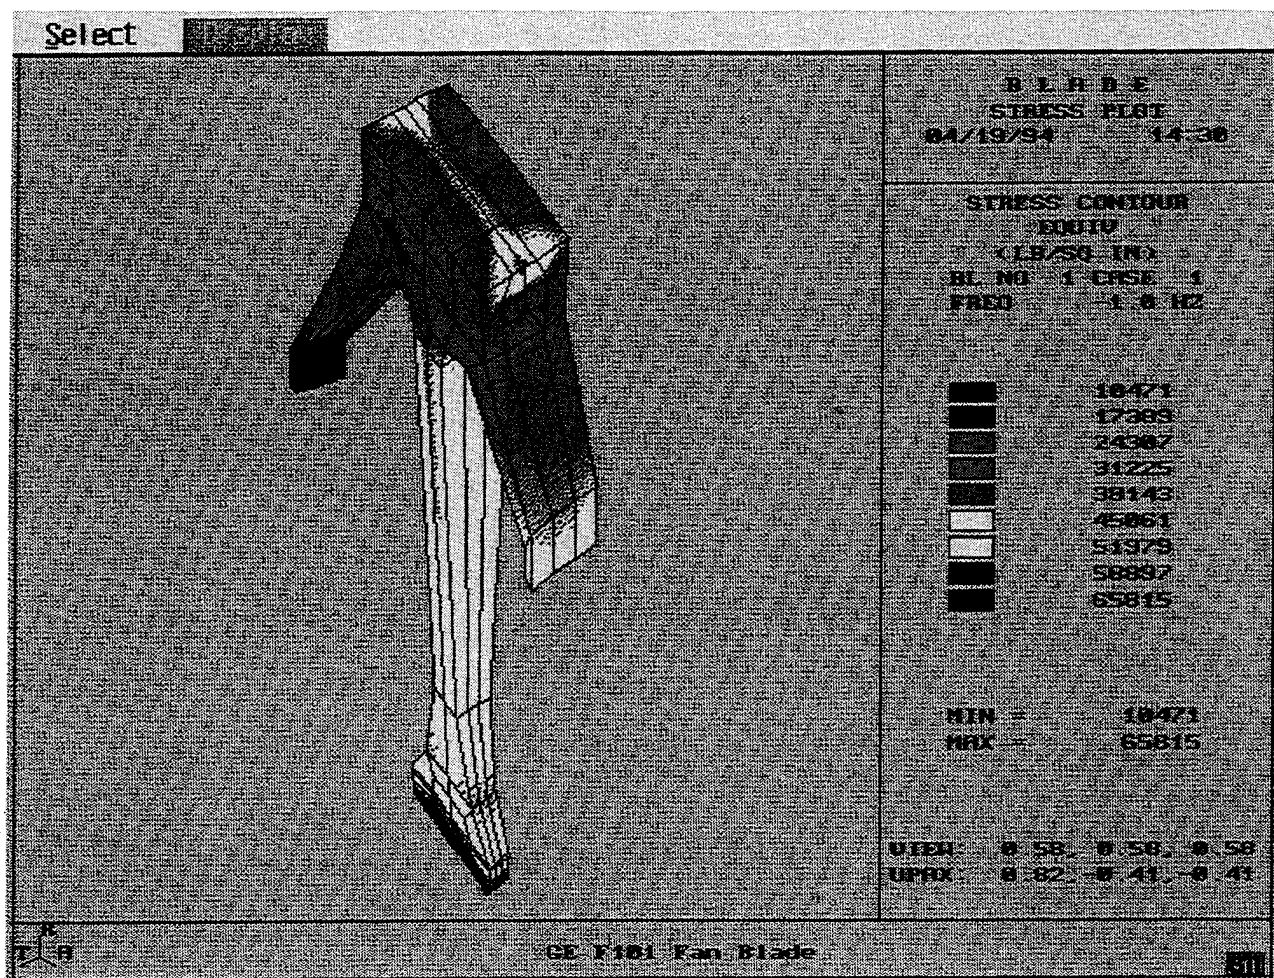
Figures 1.2 and 1.3 show the distribution of the predicted stress (von Mises stress) in the root-disk single segment from two different views. The calculated maximum stress of 65.8 Ksi was found to be at the bottom area of the disk.

FIGURE 1.2 STRESS IN A ROOT-DISK SINGLE SEGMENT

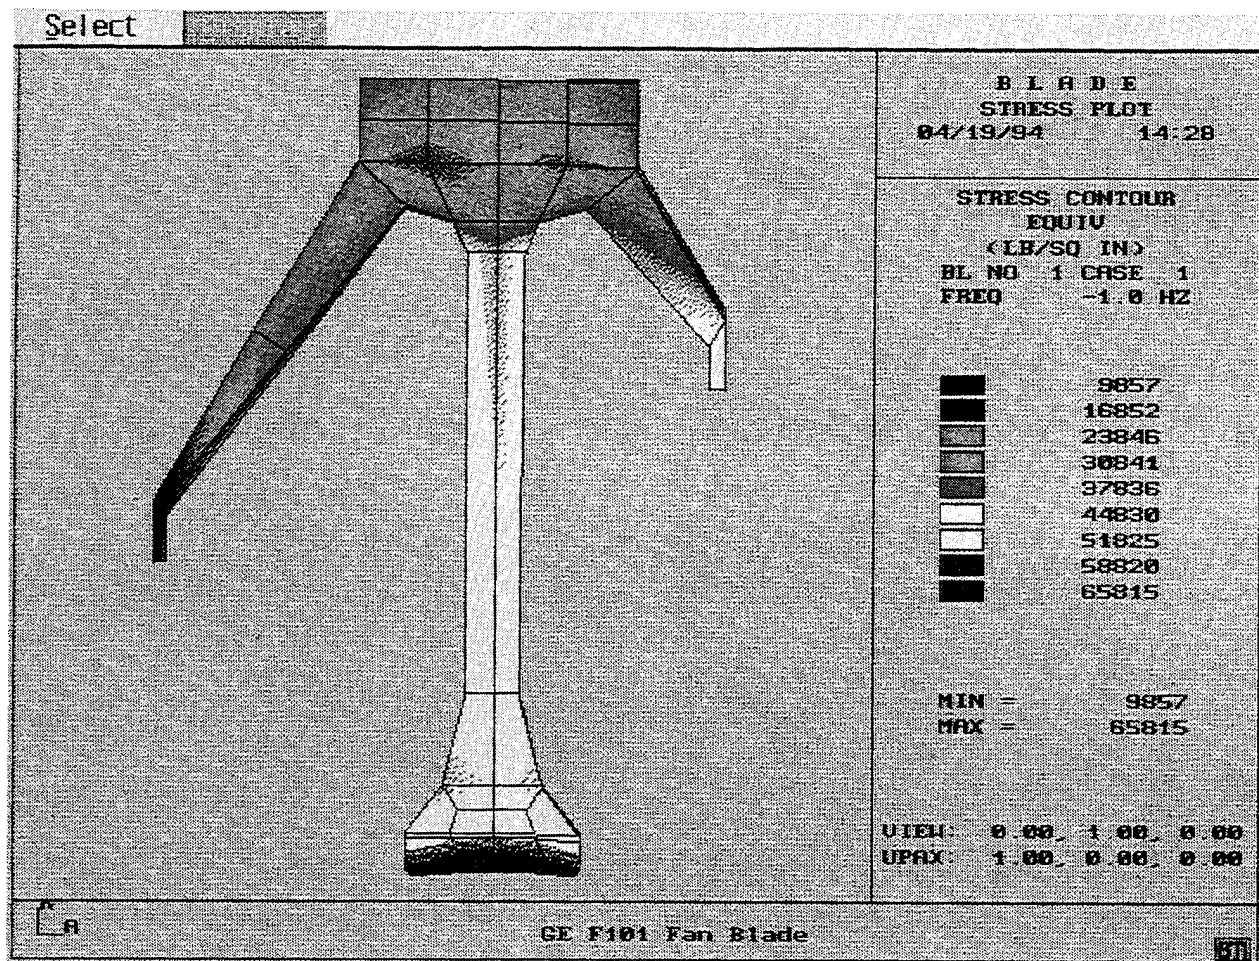
FIGURE 1.3 STRESS IN A ROOT-DISK SINGLE SEGMENT (TANGENTIAL VIEW)

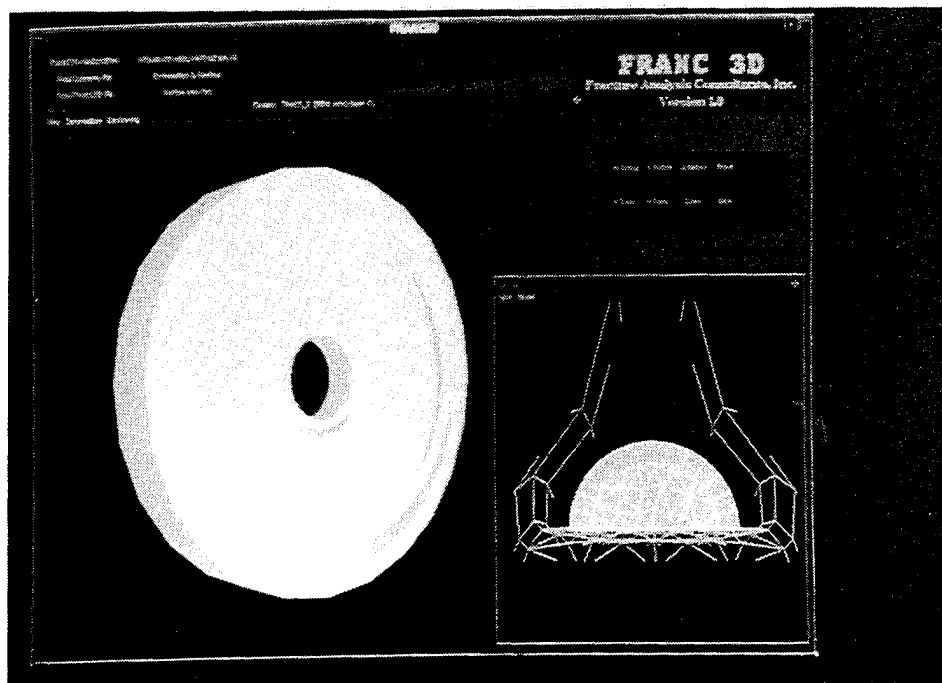
FIGURE 2.1 A SURFACE CRACK IN DISK

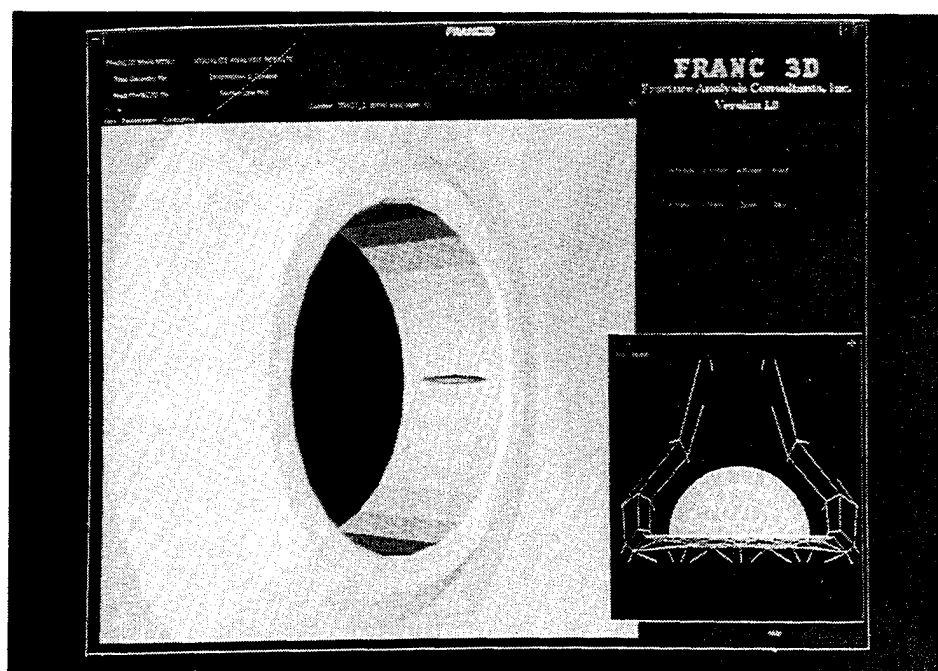
FIGURE 2.2 DETAILS OF A DEFORMED SURFACE CRACK

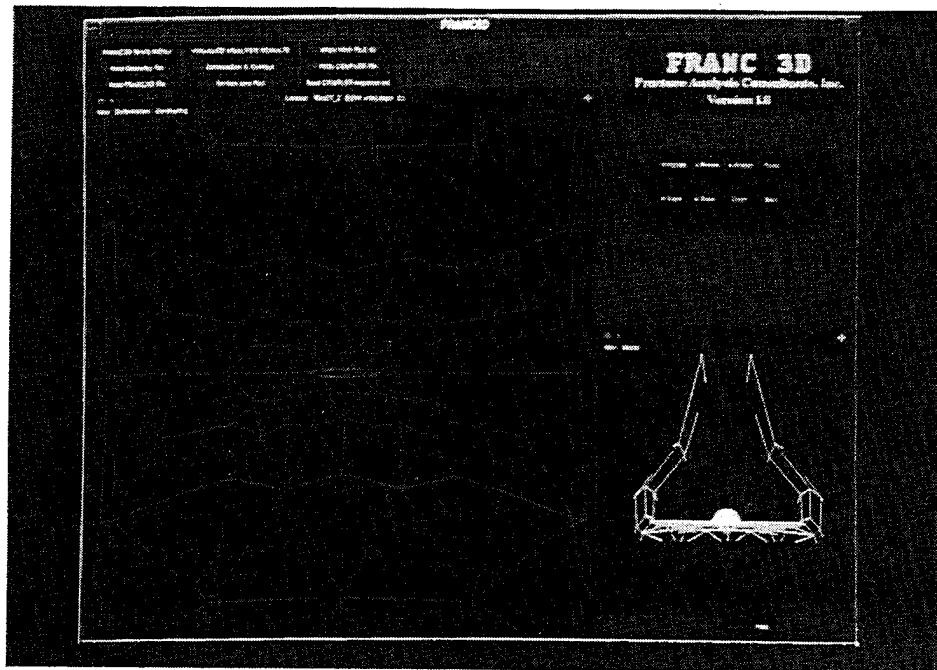
FIGURE 2.3 DEFORMATION OF A SURFACE (CENTER BORE) CRACK (VECTOR PLOT)

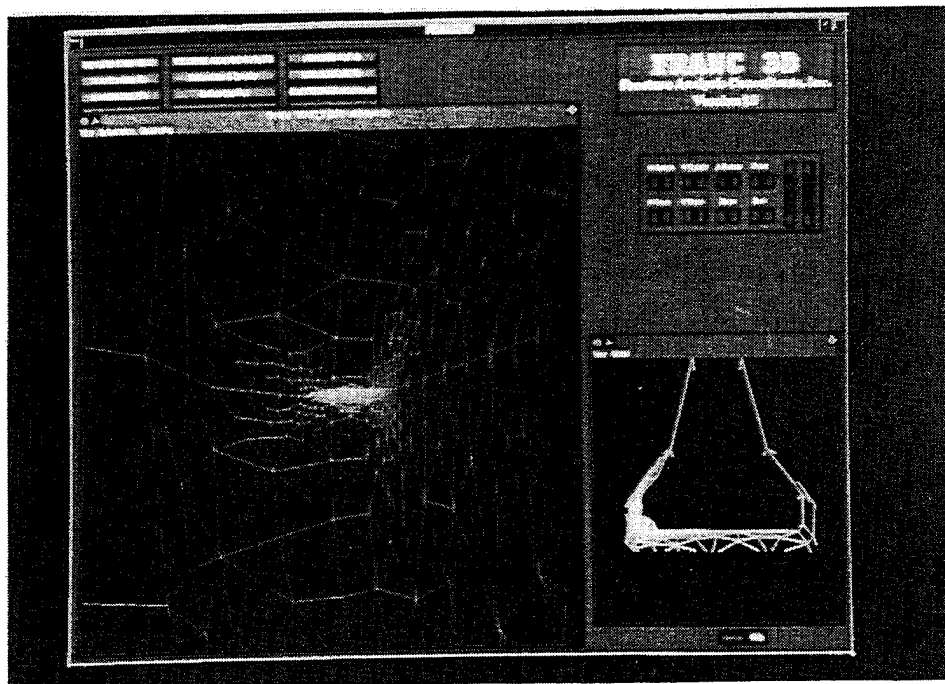
FIGURE 2.5 DEFORMATION OF A SURFACE (CORNER) CRACK (VECTOR PLOT)

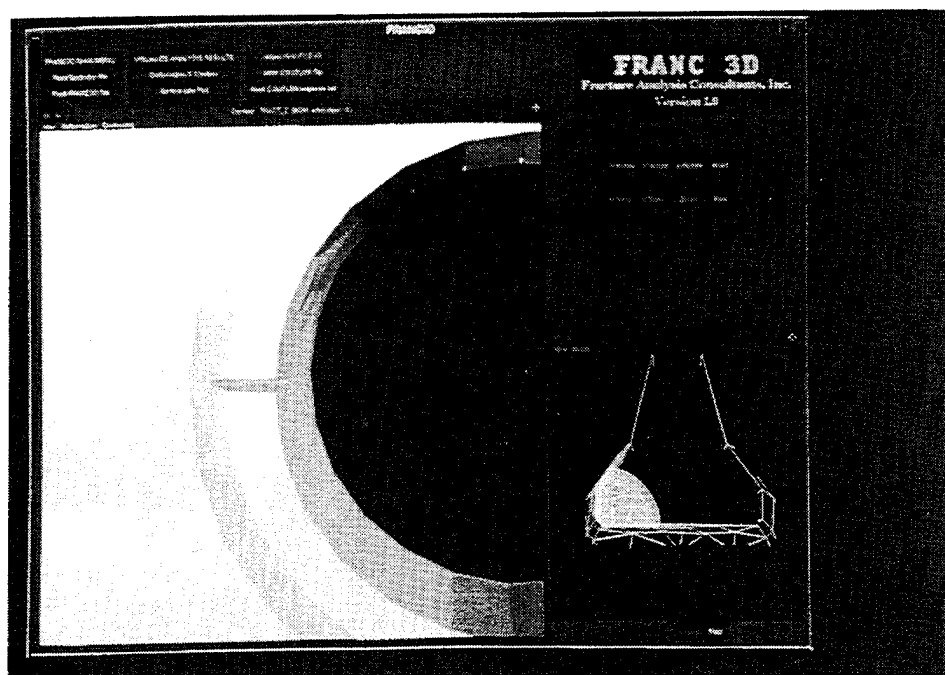
FIGURE 2.6 DEFORMATION OF A SURFACE (CORNER) CRACK (SOLID PLOT)
